Mt. Kemble Avenue Redevelopment Study

Township of Morris
Morris County, New Jersey

May 2016

Heyer, Gruel & Associates
Community Planning Consultants
236 Broad Street
Red Bank, NJ 07701
732-741-2900

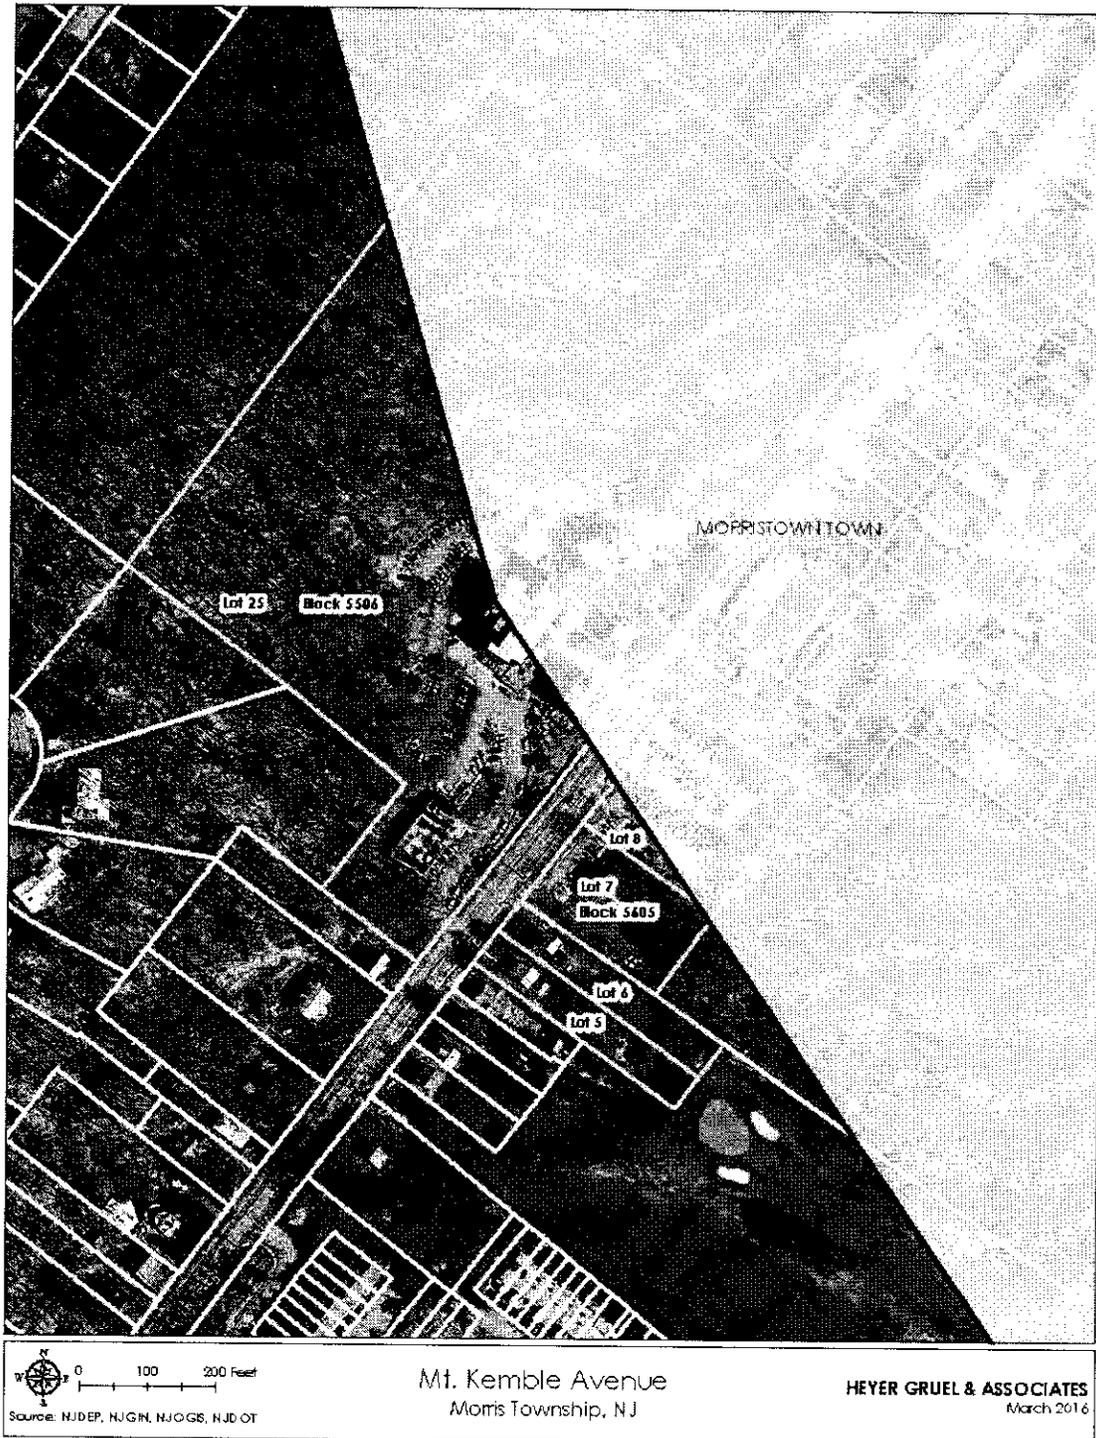
Figure 1- Study Area Map

The Redevelopment Study Area Map (see Figure 1) constitutes a "map showing the boundaries of the proposed redevelopment area and the location of the various parcels of property included therein" and also serves as the "statement setting forth the basis for the investigation which is required by Section 6(b) of the LRHL" (N.J.S.A. 40A:12A-6).

The purpose of this report is to determine whether portions of the Township of Morris, shown on the Redevelopment Study Area Map (Figure 1), referred to herein as the "Study Area", qualify as an "area in need of redevelopment" as defined in the Local Redevelopment and Housing Law (LRHL). This report is written pursuant to Section 6 of the LRHL, which provides the following:

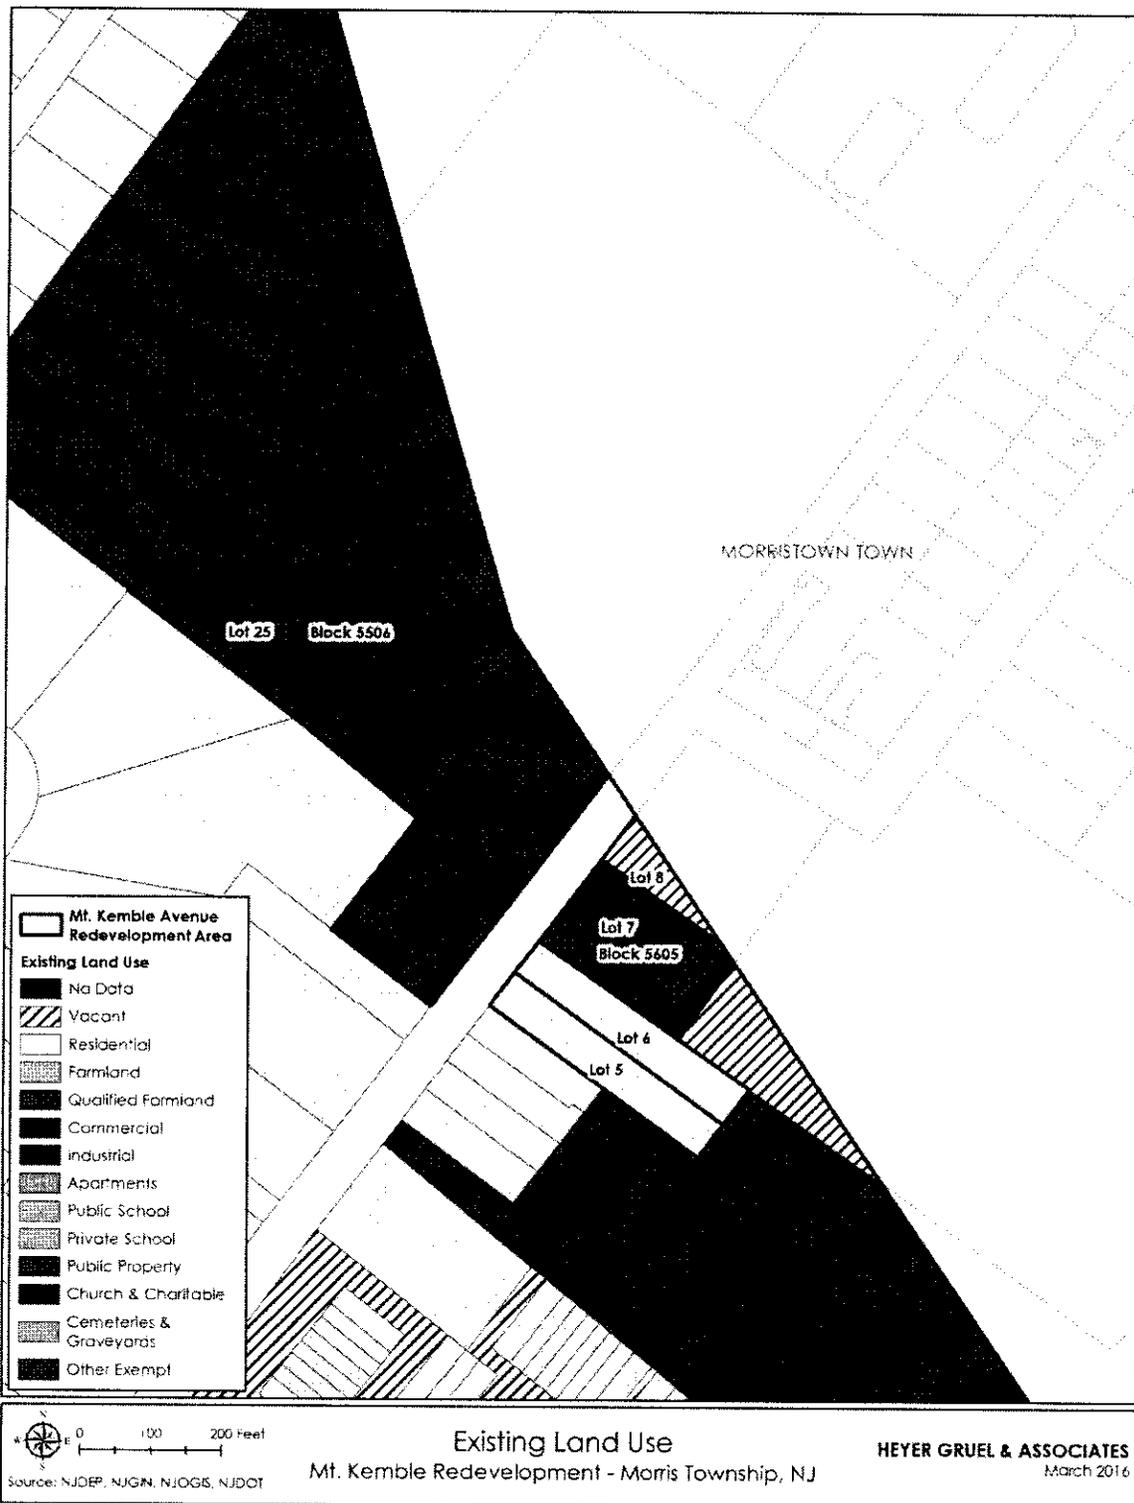
Figure 4- Existing Land Use

Across Mount Kemble Avenue are four additional lots that make up the remainder of the Study Area. Two of the lots are developed with single family homes, one is a consignment shop, and one is a portion of a parking lot for the rehabilitation facility. The majority of the parking lot is located in Morristown Town.

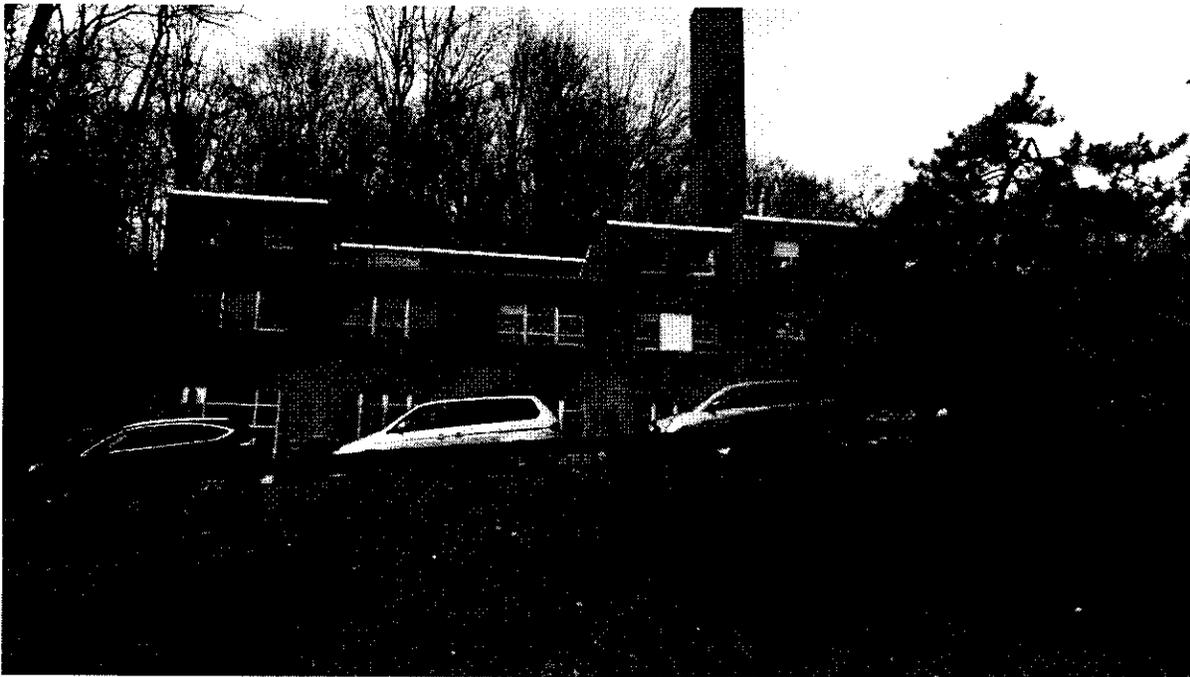
The property is a portion of the Atlantic Rehabilitation Institute facility. This lot contains the utility annex building for the facility as well as a small corner of the main building. Several parking areas and driveway aisles complete the developed portion of the site. The undeveloped portion of the site is wooded and steeply sloped.

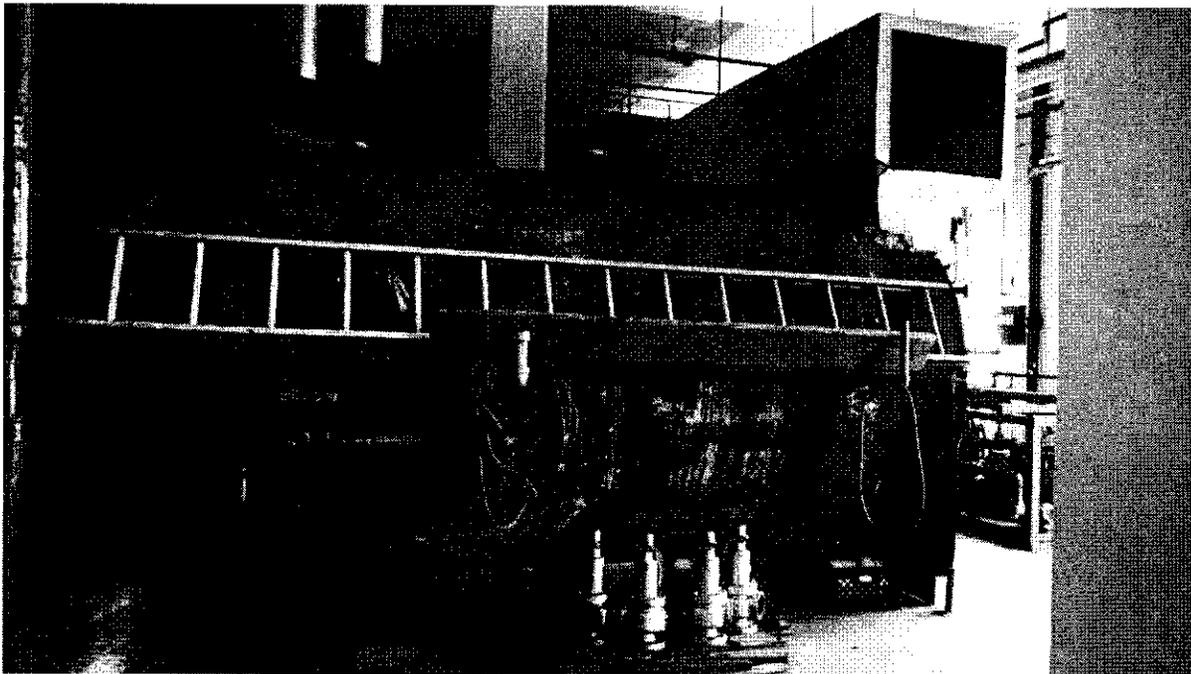
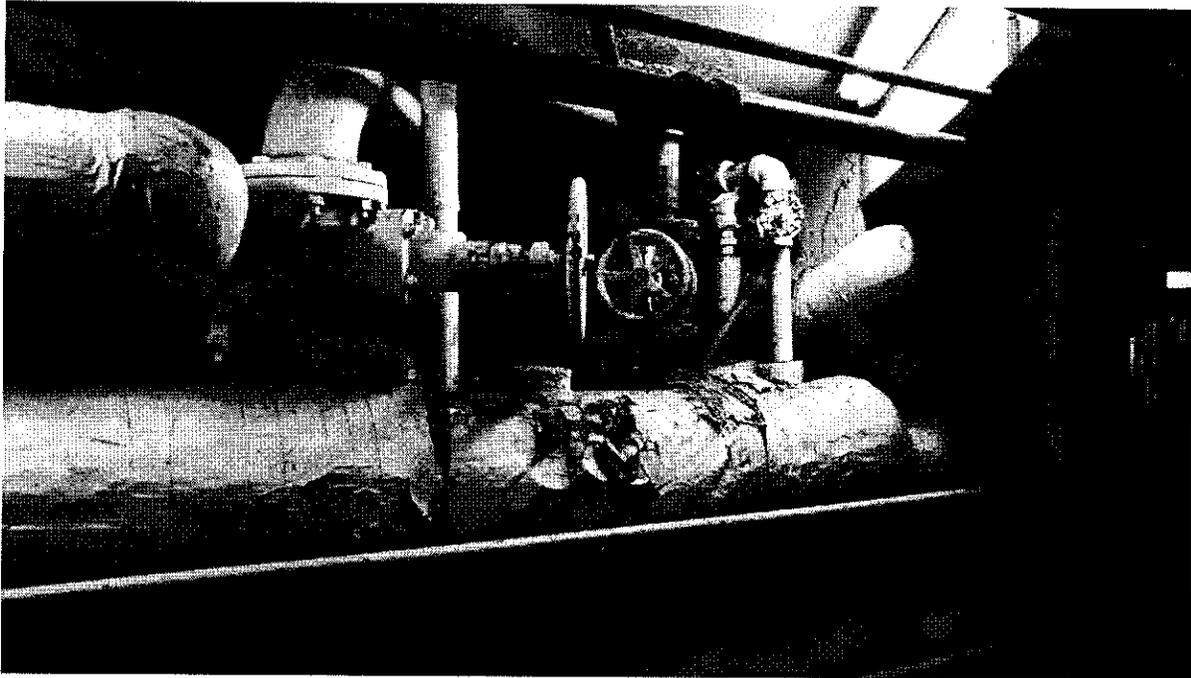
The utility annex building is connected to the main rehabilitation facility by an underground tunnel. The facility owner prepared an engineering master plan in January 2007 and a summary update in March 2016, that inventoried some of the aspects of the facility that are outdated, past their useful service life, and in need of repair or replacement. A number of these issues pertain to the utility annex building and the systems contained therein.

According to a 2007 report detailing the necessary mechanical improvements that the facility needs to remain active, and a summary of the major components of the facility prepared by the owner in March of 2016, the utility building features equipment that it is beyond its useful lifespan. The plumbing and electrical infrastructure date to 1958. The boilers located in the utility building were installed in 1958. One is entirely out of operation, the others are functioning and regularly maintained. This equipment is rated for a useful life of 25 years, and is now nearly 60 years old. The facility is continuing to function for the time being, but additional investment in upgrades to the facility may not be financially prudent.

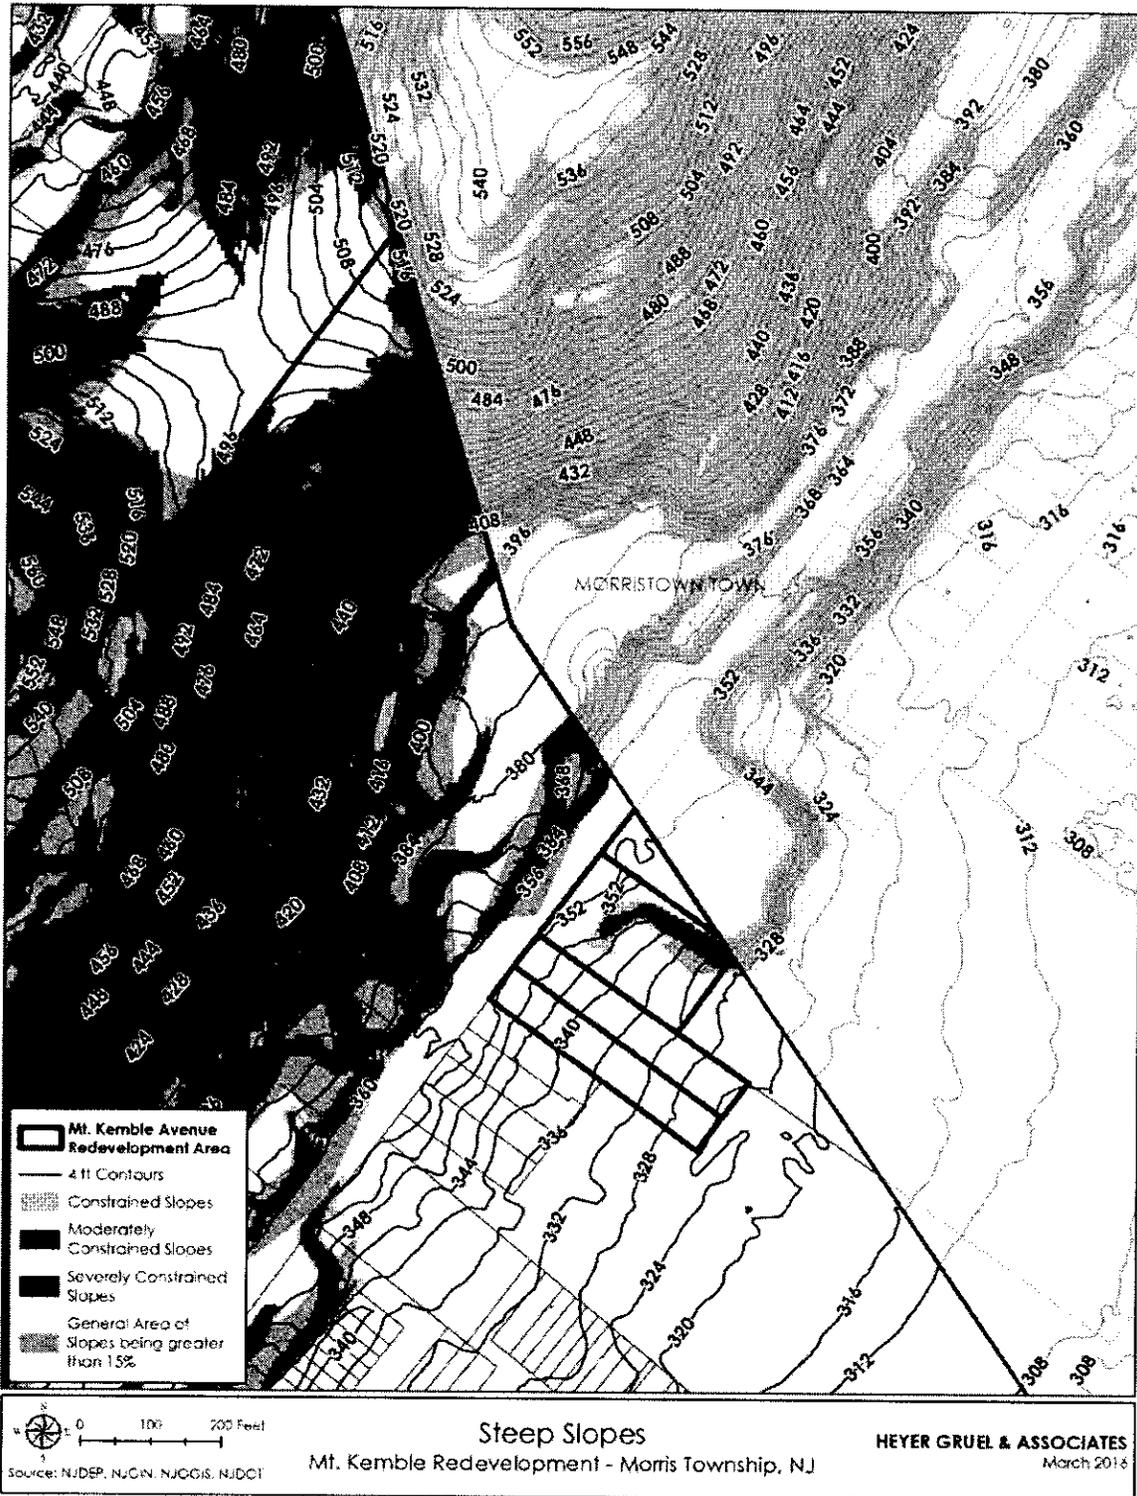
Figure 5- Steep Slopes

The on-site parking and circulation is inadequate for the facility, and the layout encourages informal, haphazard parking in undesignated areas. The facility relies on an off-site parking lot across Mt. Kemble Avenue. Expanding the developed portion of the site to provide additional parking is impossible due to environmental constraints, particularly steeply sloped areas. Figure 5 displays areas that feature slopes greater than 15% and slopes that are defined as constrained. The only portion of the site that is not constrained is the presently disturbed and developed area that the facility occupies.

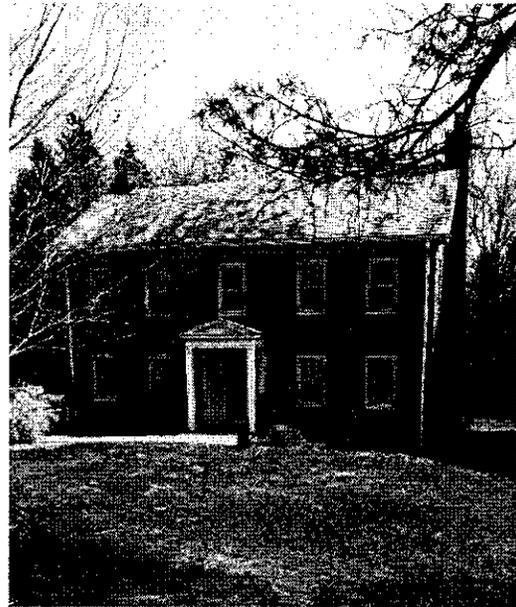
Lot 6 in Block 5605 is approximately half an acre in size. It fronts on Mt. Kemble Avenue and is located across the street from the rehabilitation facility. The property is developed with a single-family residence that was built in 1887. The property is owned by the Memorial Realty Corp., a division of Atlantic Health Systems. According to the Atlantic Health Systems property manager, the residence is used as a rental property, and is currently occupied.

A site visit and review of the exterior condition of the house shows the need for some cosmetic improvements and maintenance. A review of building department records revealed an open permit for a shed, but no other permits or violations.

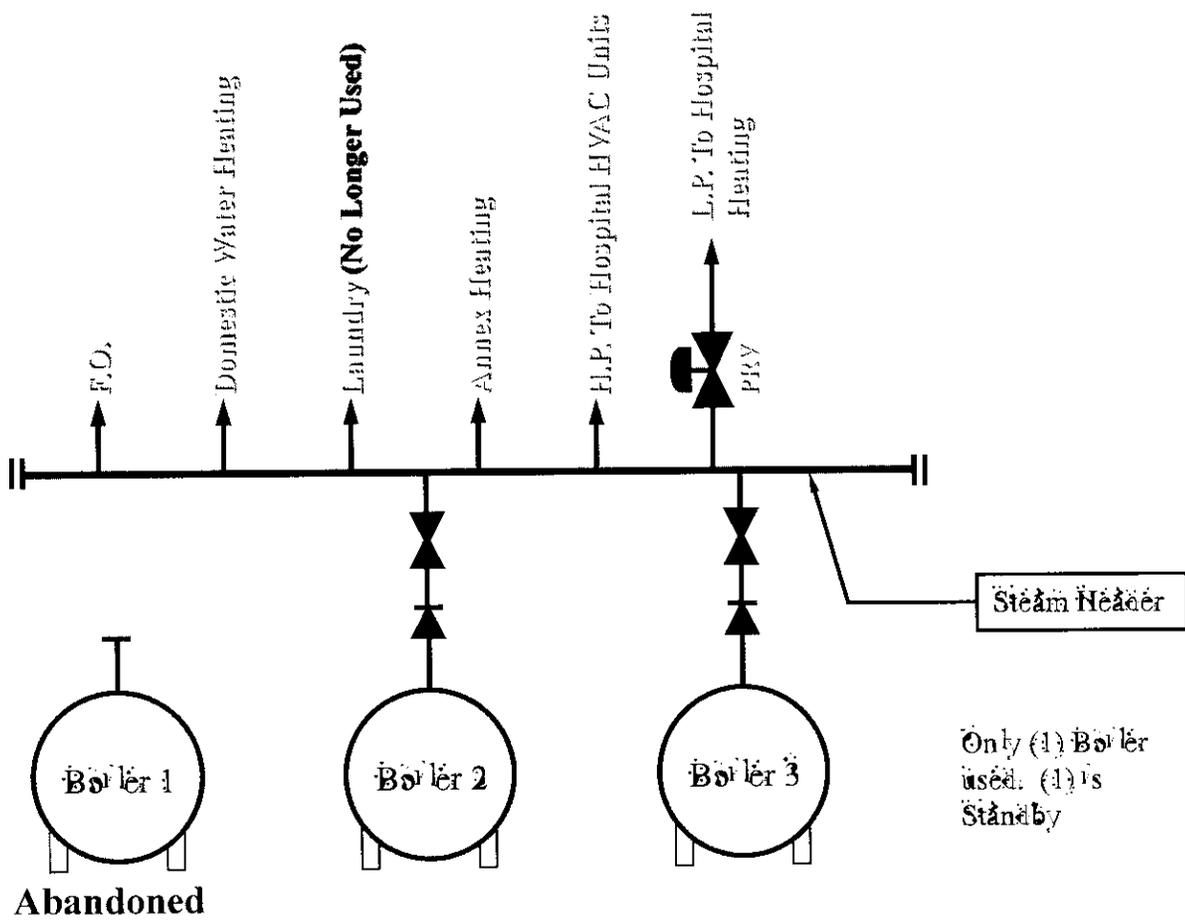
Steam & Condensate Systems

- Central Boiler Plant In Annex Serves All Except Thebaud Building
- HP And LP Mains Through Tunnel
- Three Fire Tube Steam Boilers Installed In 1958, One Is Abandoned And Unserviceable
- Boilers Are Natural Gas Primary, No. 6 Oil Back-up. Each Rated For 300 BHP And 150 PSIG Maximum Pressure
- Manual Blowdown
- Current Boiler Operating Pressure Is 45 PSIG

- Replace Boilers And Auxiliaries.
- Consider Small Boiler Dedicated For Summer Load. (Domestic Water And Reheat)
- Install New Steam And Condensate Distribution Piping
- Install Dearator And Surge Tank With Maintenance Bypasses
- Extend Steam Or Hot Water Service To Thebaud To Replace Electric Heat
